Historical Radiological Assessment

Volume II

Alameda Naval Air Station

Use of General Radioactive Materials, 1941-2005

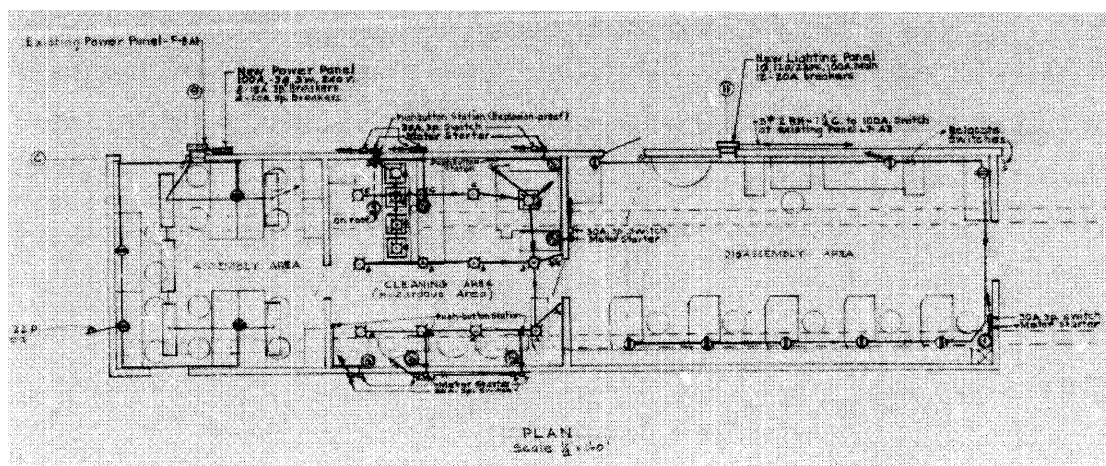
Figure 6-7 Location of new radium paint shop in 1954.

In July 1953, former NAS submitted a request for funds to consolidate and control the disassembly of radium painted instruments with the repainting of those instruments still requiring the use of radium paint. The submittal noted that controlled methods were applied in the disassembly, stripping, and painting of instruments. However, the disassembly of the instruments posed a health hazard due to resulting dispersal of paint particles (ALA-HRA-72). In 1954, NAS moved the radium paint shop portion of the instrument shop to a third location in the middle section of the mezzanine (Figures 6-7 and 6-8). There were no documented reports of violations of radium instrument repair operations. Over the course of approximately 13 years, the radium paint facility occupied three separate sets of rooms in the mezzanine floor of Building 5 as shown in Figure 6-5.

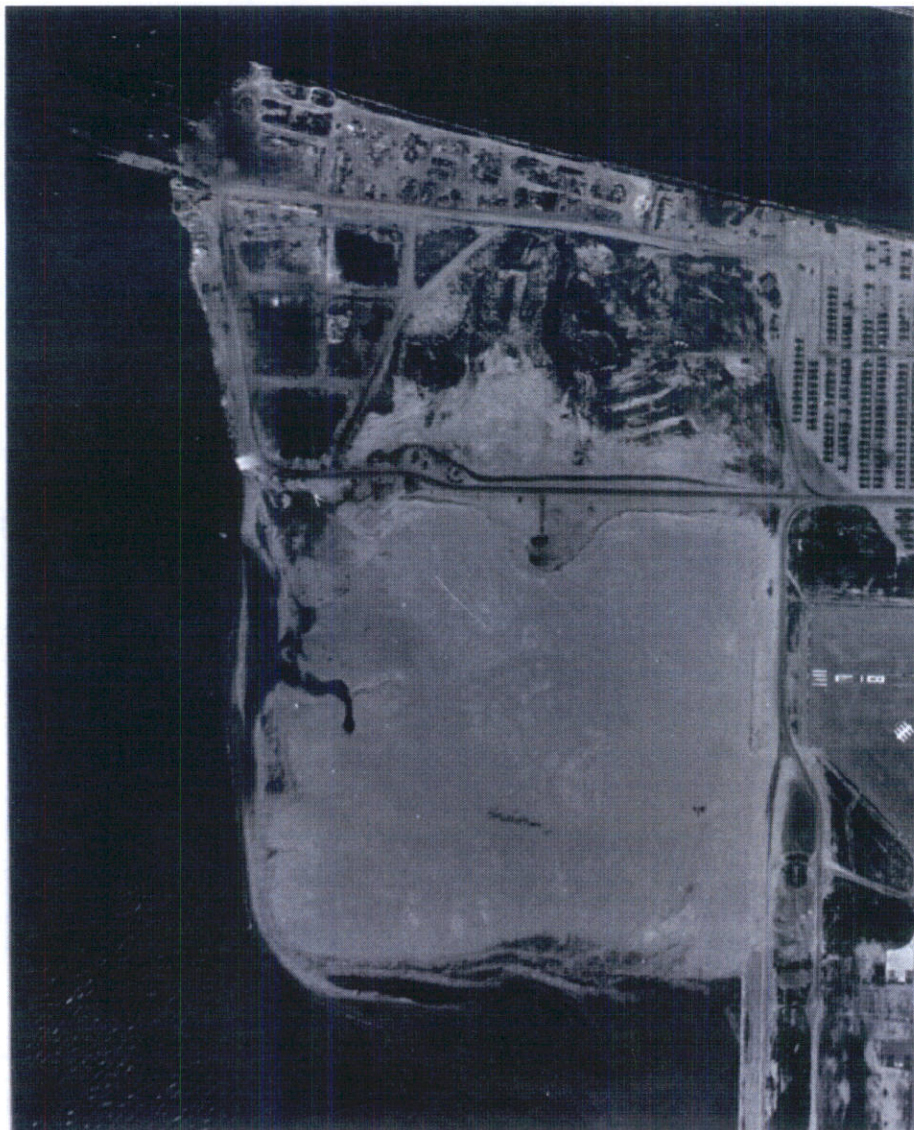
Figure 6-10 IR Site 1 1947

Radium waste was disposed of in the storm drain system leading from Buildings 5 and 400 and into the Seaplane Lagoon. The 1979 RASO Technical Assistance visit report questioned the quantity of radium discharged from the deep sink. Radium waste was also disposed of in IR Site 1, 1943-1956 Disposal Area, and into IR Site 2, West Beach Landfill, which operated from 1952 to 1978. NAS used IR Site 1 at the northwest end of Alameda point as an industrial and non-industrial waste disposal area from the early 1940s until 1956. Early photographs of IR Site 1 location show that the area was underwater until dredging and filling reclaimed the area. Later photographs show the existence of at least six disposal areas (Figure 6-10).

IR Site 1 includes a former rifle range, several buildings, a jogging trail, and portions of two runways. During the time the disposal area was in use, it is likely that all waste generated on the naval air station, both household and industrial, was disposed of there. Radioactive wastes were clearly disposed of in IR Site 1. The early Navy direction for disposal of radium waste from the radium paint facility is clear in directing that liquid wastes be "...emptied directly into the sewage system or deposited in a hole in the earth." Dry waste such as wiping papers used to wipe up excess solvent was to be "...permanently disposed of outside the workrooms, by

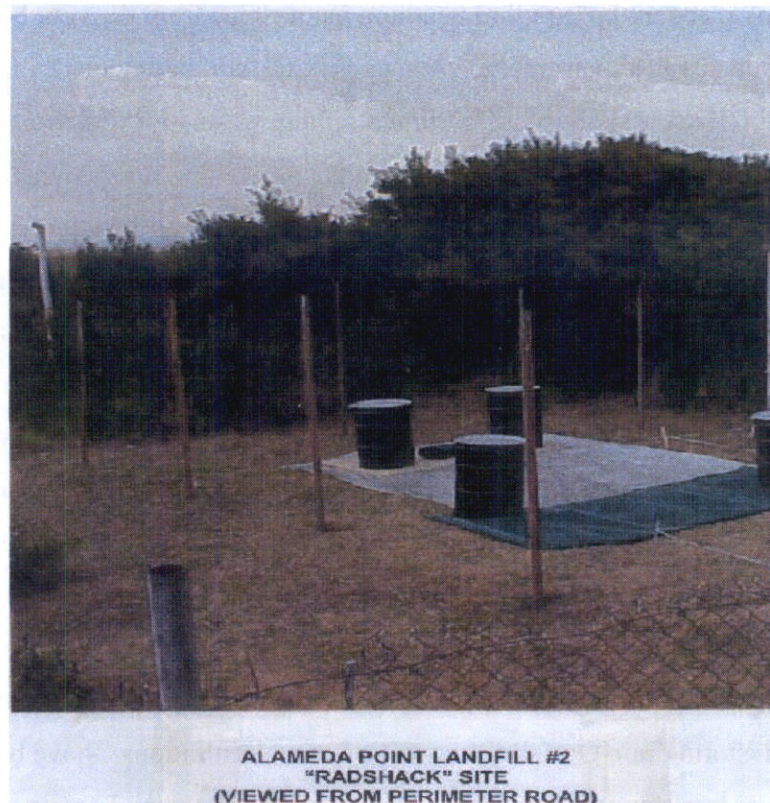
Figure 6-12 Site of RadShack Area (1999 photo)

A fenced in area known as the RadShack Area was located inside the boundary of IR Site 2. It is discussed separately because it has a radiological history of its own. The RadShack Area was originally a small wood frame structure surrounded by a locked security fence in the West Beach landfill area just west of Bunker 353. In 1973 the RASO Technical Assistance visit report noted that radioactive waste from Building 400 was sent to the dump for storage in a fenced-in area until picked up by a licensed disposal firm (**ALA-HRA-29**). The 1977 RASO Technical Assistance visit report noted that the waste from Building 400 would be wrapped in plastic bags and packaged in cardboard boxes. Inspection of the RadShack Area during this visit identified a small metal drum with stenciled marking 'Danger, Radioactive Material Inside'. RASO noted that the damp environment could cause the cardboard boxes containing radioactive waste to deteriorate (**ALA-HRA-30**). The 1979 RASO Technical Assistance visit report observed 25 boxes of various sizes labeled radioactive. In addition, there were several small cans marked radioactive and four barrels containing magnesium. The cardboard boxes were beginning to deteriorate as predicted in the 1977 visit (**ALA-HRA-43**). The 1980 RASO Technical Assistance visit report observed two drums with radioactive glass prisms stored in the RadShack Area (**ALA-HRA-44**). Sometime between the 1980 visit and the 1983 visit, the RadShack was emptied. One of the RASO representatives present during the 1983 technical assistance visit reported seeing some radioactive oxygen selector switches on the ground in the fenced-in area (**ALA-HRA-76**). A survey of soil in a controlled area around the building indicated contamination on the ground. A soil sample was analyzed and shown to contain Ra-226 at a concentration of 1.42 picocuries per gram (pCi/g) above background (**ALA-HRA-45**). The Radshack was disposed of in approximately 1998 leaving only the support posts (Figure 6-12).

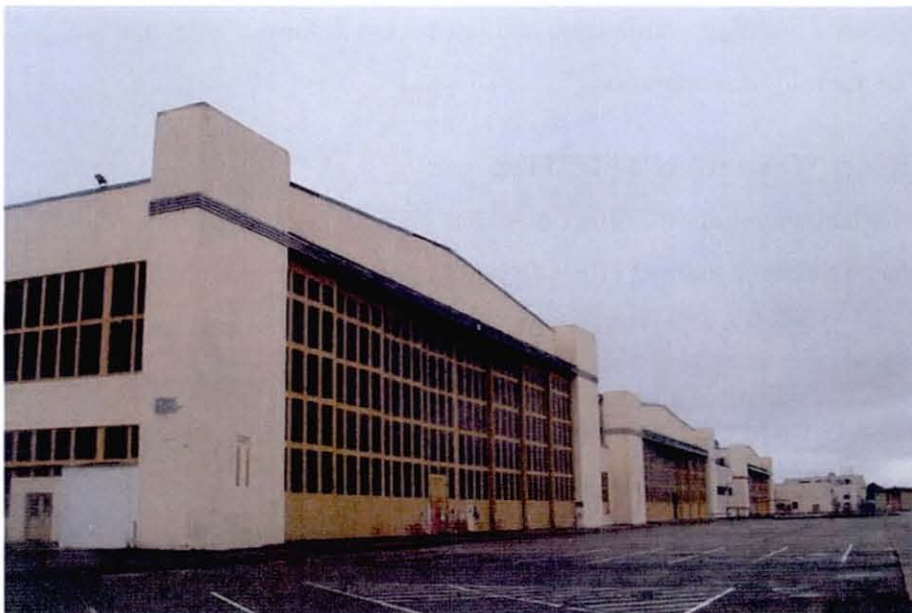
Figure 8-3.1.1 Building 5

Site Description: Building 5 served as the Overhaul and Repair Shop. It was initially constructed in 1940, although it was remodeled and added to many times. In the final configuration Building 5 was over 910,000 ft². The building had very high ceiling to accommodate aircraft and overhead cranes. Multiple mezzanines ran east and west down the center of the building. Radium dial painting facilities were set up in three different locations (as described in Section 6.1.1) in the center section of the mezzanine over the years from 1941 through the mid 1950s (ALA-HRA-56, 58, 60, 72). Surveys have detected radium contamination in several different rooms on the mezzanine. Drain piping from the mezzanine was contaminated by disposal of liquid radium waste. The drain piping was connected directly to the storm drain system on the west side of the building. DU counterweights were handled and stored on the main floor (ALA-HRA-43). Tritium exit signs were stored in the former x-ray room on the first floor (ALA-HRA-82). Figure 8-3.1.2 provides a site plan and Figure 8-3.1.3 provides floor plans of the building.

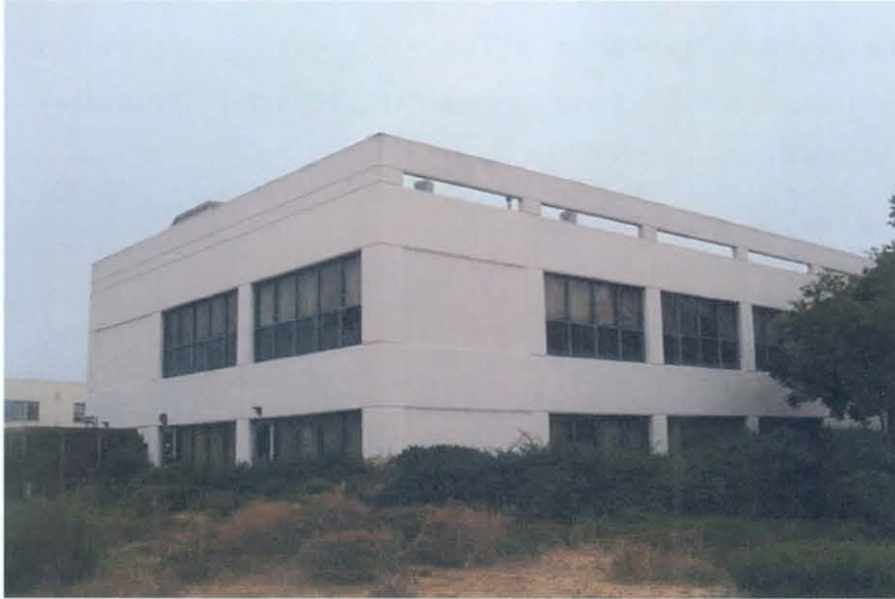
Figure 8-3.2.1 Building 7

Site Description: Building 7 is a two-story concrete structure built in 1985. This building served as the Material Engineering Laboratory from 1985 until base closure. Two gas chromatograph units were installed on the second floor. NRC Material License 04-19811-01 was issued for possession of Ni-63 sources utilized with the gas chromatographs (ALA-HRA-37). One of the Ni-63 sources was lost in 1989 (ALA-HRA-88). The source was last seen in a cabinet on the second floor of Building 7. It was never recovered. A replacement source was obtained. Records indicate one gas chromatograph was used in Room 212, and the source for one unit was stored in room 205 (ALA-HRA-94). During base closure operations, the Ni-63 source for one gas chromatograph unit was transferred to the vendor in 1996. The second source, for the other unit, was transferred to the vendor in 1997. Wipe tests were performed on both sets of Ni-63 sources before transfer back to the vendor were negative (ALA-HRA-92 and 93). The wipe tests confirmed that neither of the source sets was leaking. Figure 8-3.2.2 provides a site plan.

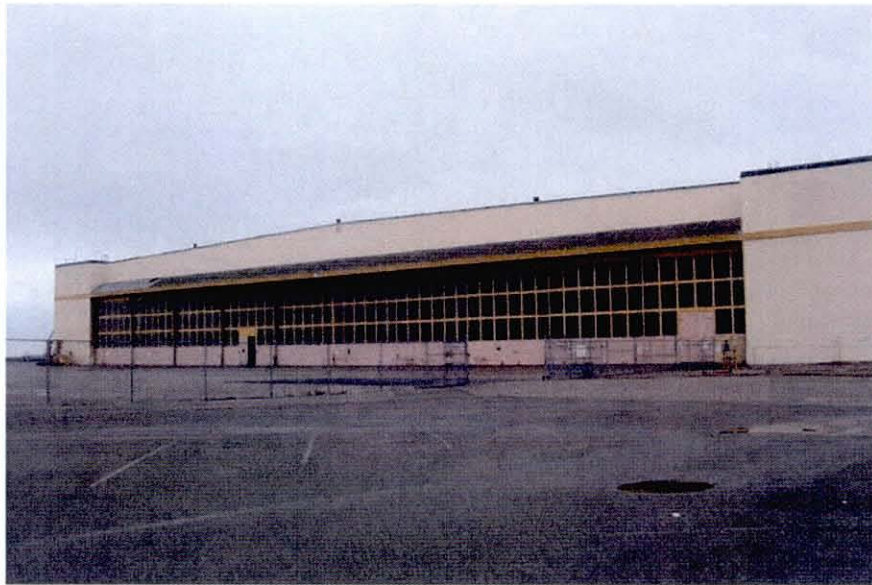
Figure 8-3.3.1 Hangar 12

Site Description: Hangar 12 is a steel and concrete aircraft hangar. It was built in 1941 as the aircraft rework shop. The hangar covers approximately 110,000 ft². A small area in the northeast corner was roped off and used for inspection of DU counterweights. Figure 8-3.3.2 provides a site plan.

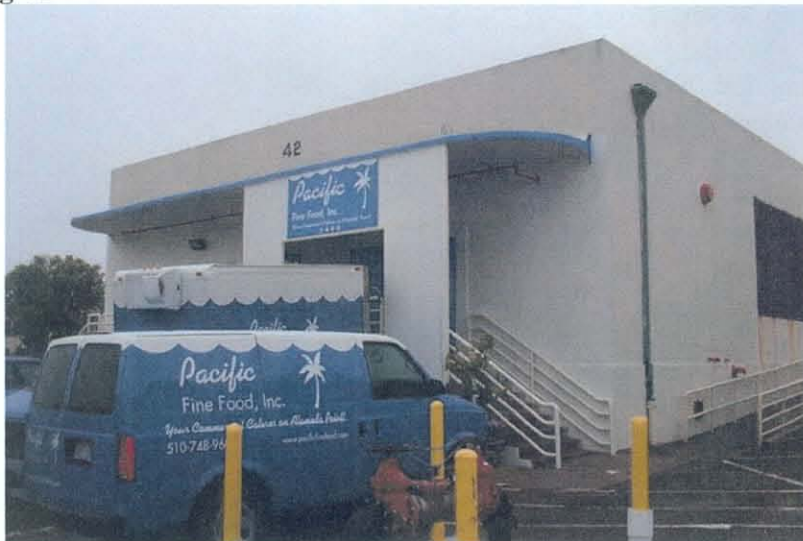
Figure 8-3.4.1 Building 42

Site Description: Concrete one-story building. Building 42 was constructed in 1941 and was the Engineering Laboratory until replaced by Building 7 in 1985. This building of approximately 3,000 ft² was the original location for the Ni-63 gas chromatograph. The NRC Material License 04-19811-0 was initially issued for possession of Ni-63 sources in Building 42 (ALA-HRA-37). The NRC license was transferred to Building 7 in 1986. The NRC license was converted to an NRMP in 1987 (ALA-HRA-38). Note: Leak tests of Ni-63 sources in Building 7 in 1996 and 1997 were negative (ALA-HRA-92 and 93). Figure 8-3.4.2 provides a site plan.

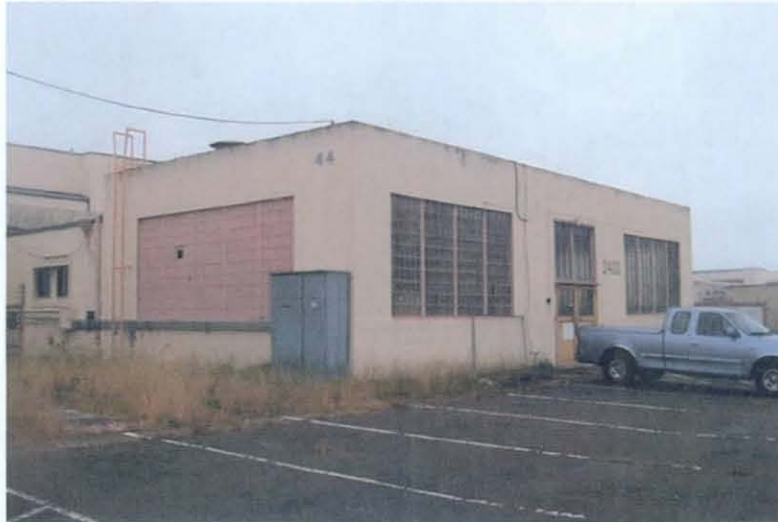
Figure 8-3.5.1 Building 44

Site Description: Building 44 is a single-story concrete and steel building constructed in 1941. The building was originally the Engineering Office Facility. It covers approximately 5,000 ft². Figure 8-3.5.2 provides a site plan.

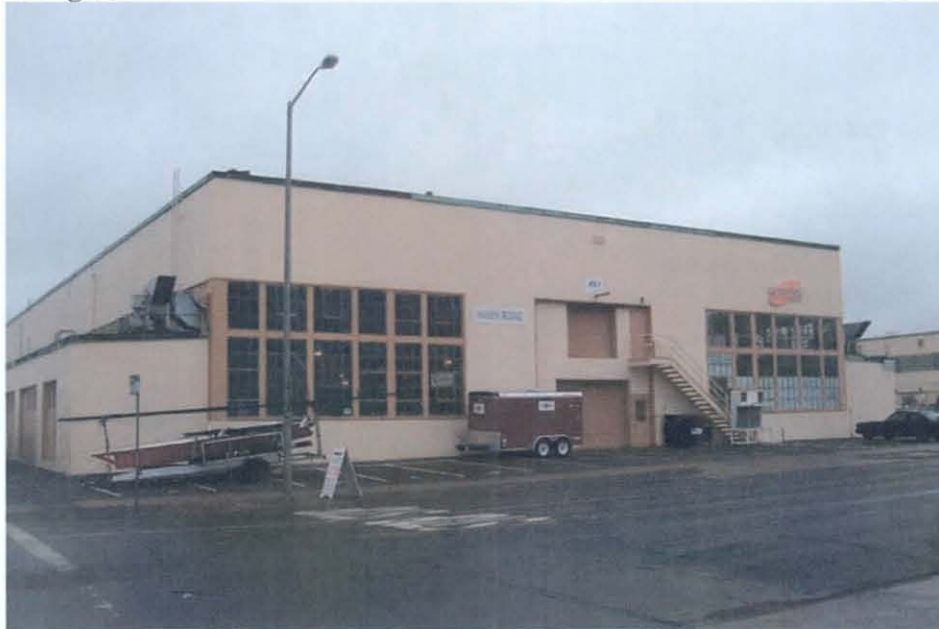
Figure 8-3.6.1 Building 66

Site Description: Building 66 is a single-story concrete and steel structure built in 1942. The one-story high bay building covers approximately 31,000 ft². There are two small mezzanine areas above the main floor. Figure 8-3.6.2 provides a site plan.

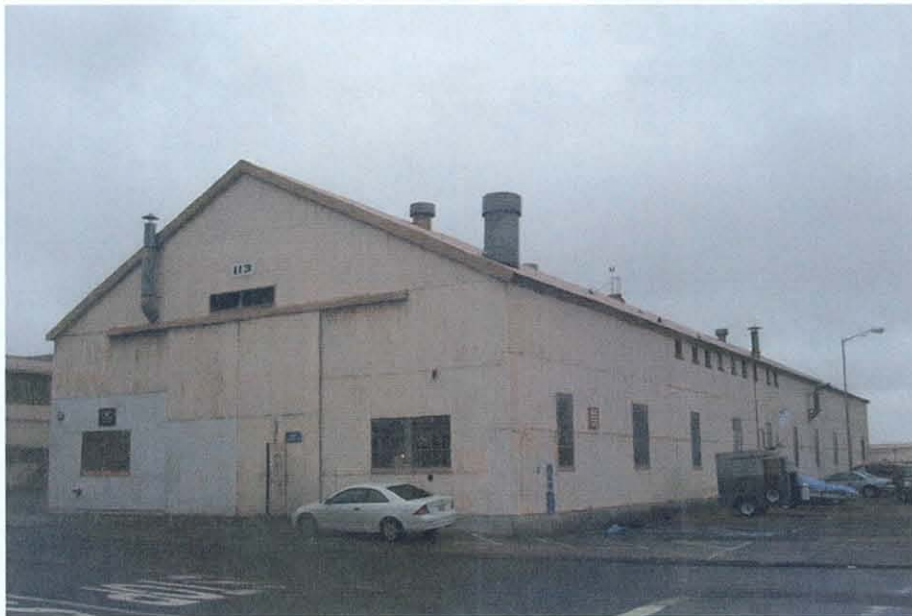
Figure 8-3.7.1 Building 113

Site Description: Building 113 is a sheet metal and steel pre-built structure initially built in 1943. It was moved in three sections to its current location in 1948. It has functioned as an aircraft parts shipping container overhaul building. Figure 8-3.7.2 provides a site plan.

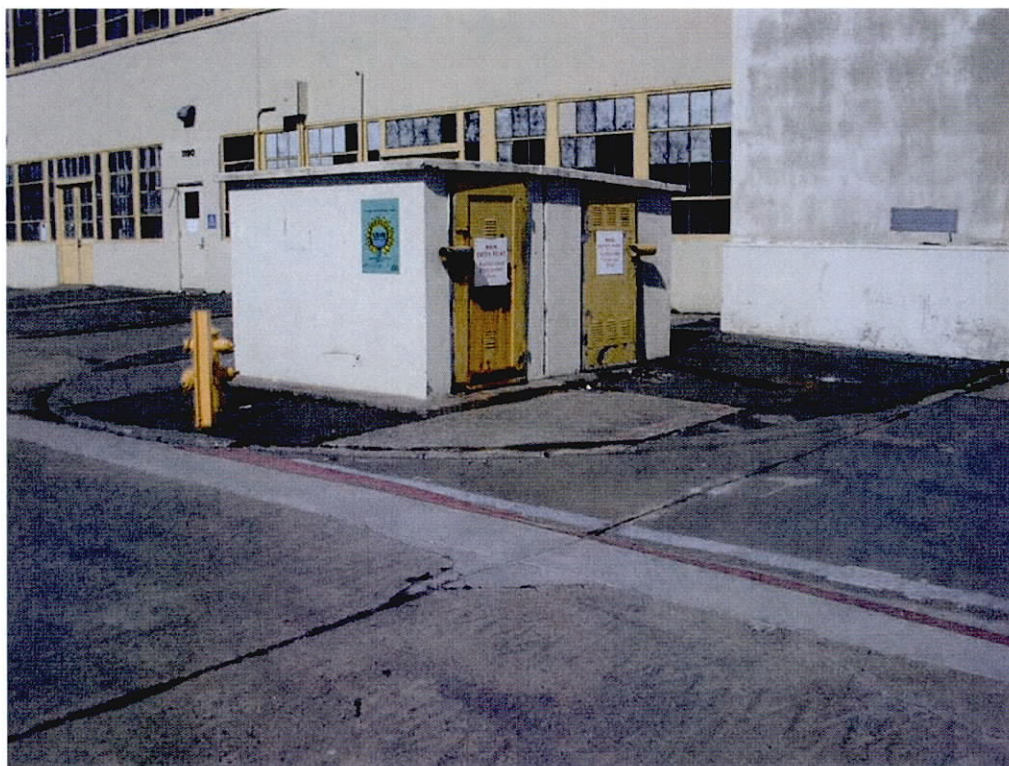
Figure 8-3.9.1 Building 309

Site Description: A small concrete storage bunker with two rooms on one side and a third room on the opposite side. Building covers about 110 ft². This building is located on the southeast corner of Hangar 12. Figure 8-3.9.2 provides a site plan.

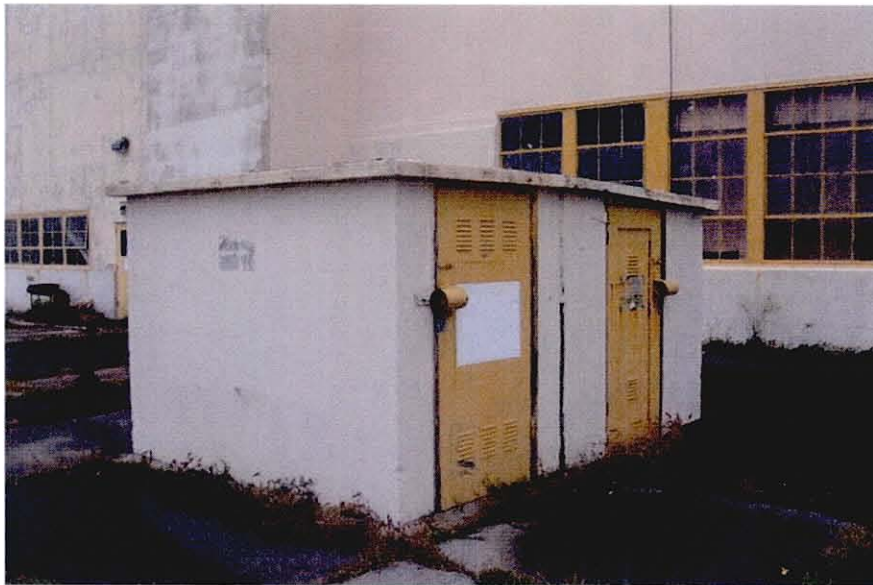
Figure 8-3.10.1 Building 310

Site Description: A small concrete storage bunker with two rooms on one side and a third room on the opposite side. Building covers about 110 ft². This building is located on the southeast corner of Building 400. Figure 8-3.10.2 provides a site plan.

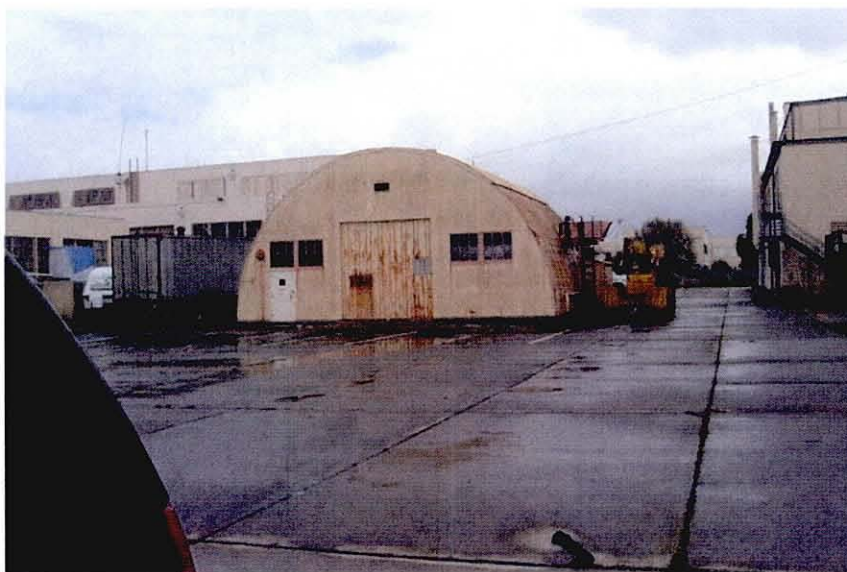
Figure 8-3.11.1 Building 346

Site Description: Building 346 is a Quonset hut type building constructed of sheet metal with a steel frame. The building is located immediately west of Building 5. Figure 8-3.11.2 provides a site plan.

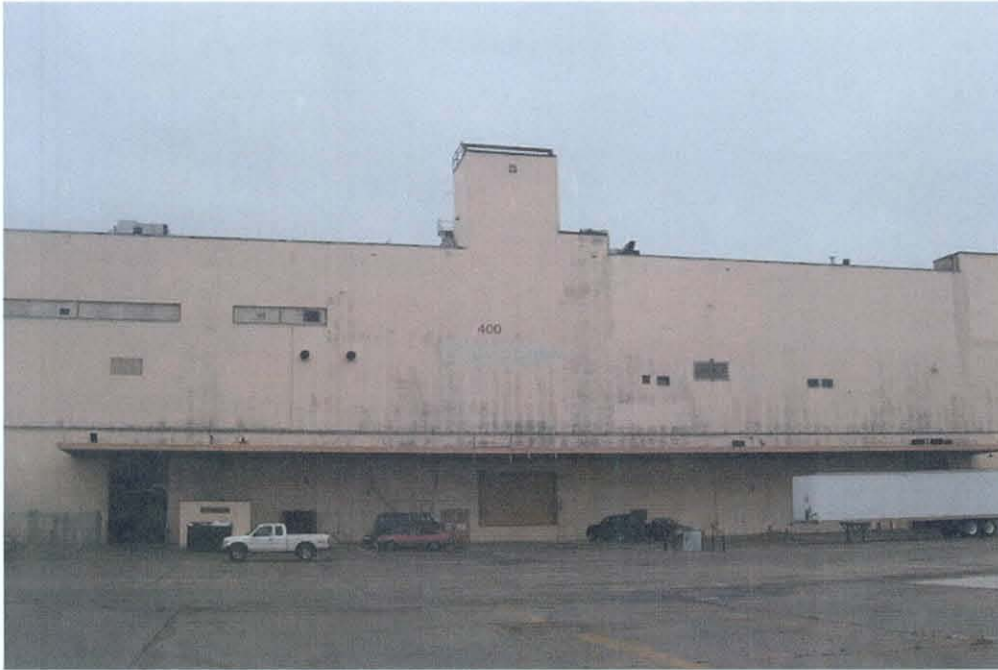
Figure 8-3.13.1 Building 400

Site Description: Building 400 is a large concrete and steel structure covering approximately 257,000 ft². It has a very large high bay area on the south half of the building and three floors on the north half of the building. Building 400 was constructed in 1957 and assumed some of the functions of Building 5 (ALA-HRA-126, 112). Figure 8-3.13.2 provides a site plan and Figure 8-3.13.3 provides a floor plan of the second floor.

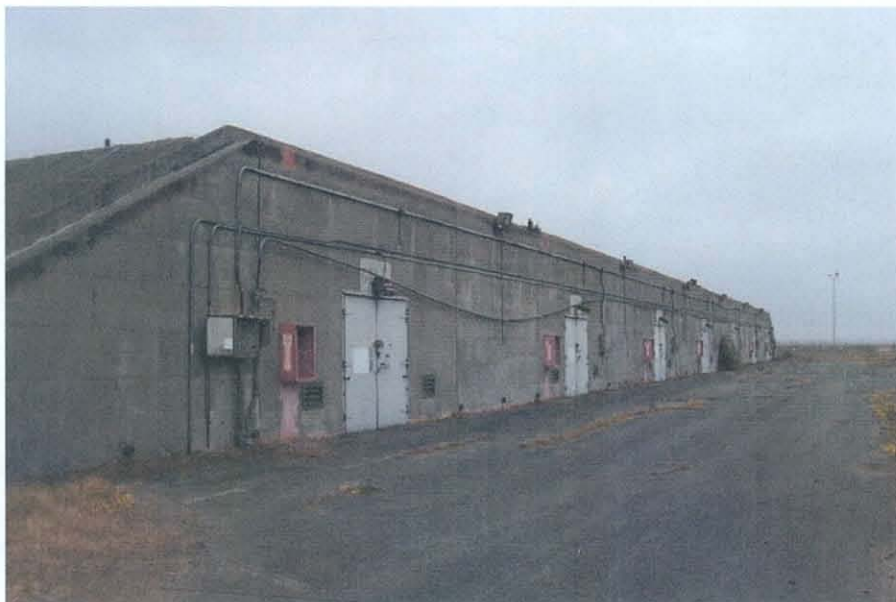
Figure 8-3.14.1 Bunker 497

Site Description: A large 7-cell special weapons magazine built in 1964. Each cell of the bunker had its own entrance and each cell provides floor space of approximately 750 ft². Figure 8-3.14.2 provides a site plan.

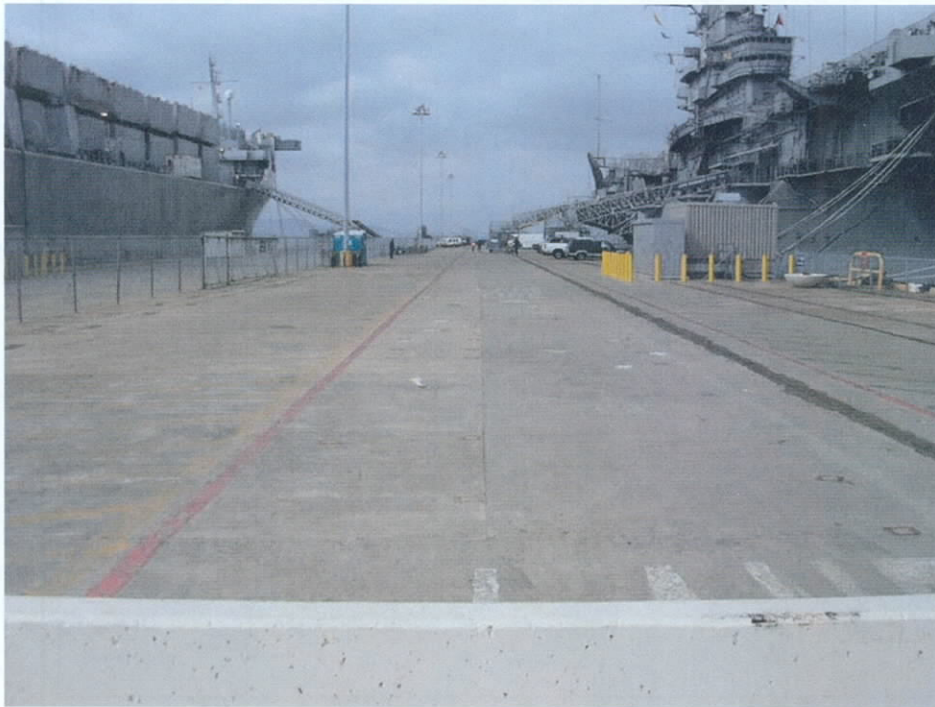
Figure 8-3.18.1 Pier 3

Site Description: The largest of the three piers. Pier 3 was capable of supporting berthing of two aircraft carriers at the same time. Figure 8-3.18.2 provides a site plan.

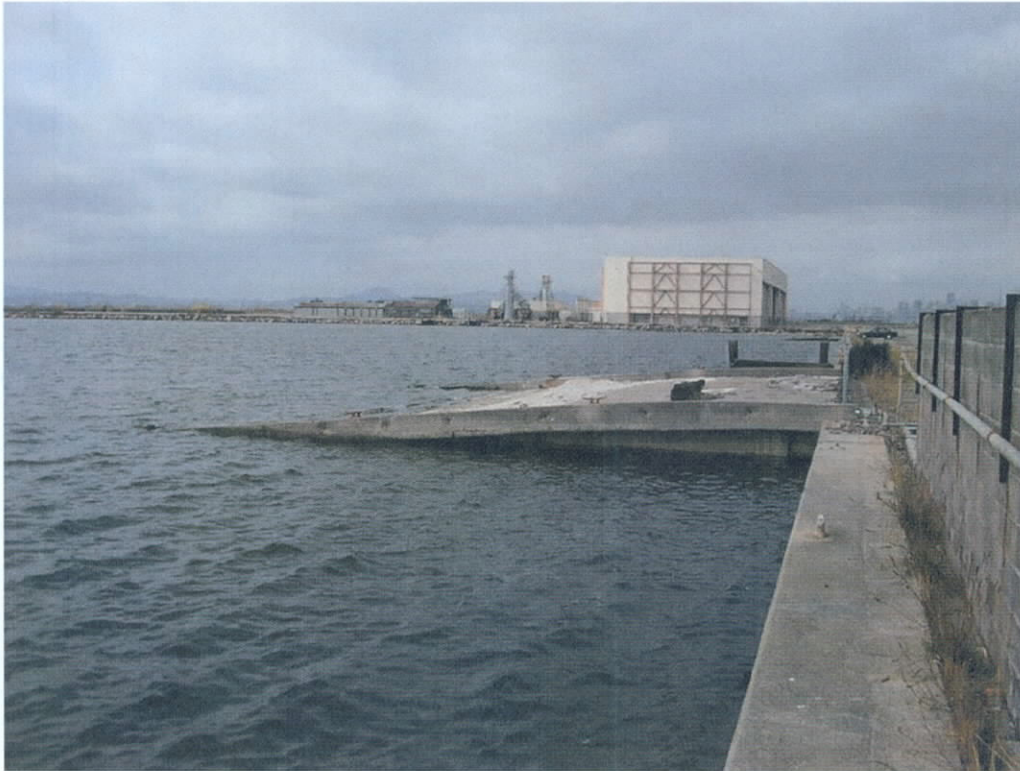
Figure 8-3.20.1 Seaplane Ramp and Parking Apron

Site Description: The Seaplane ramp is the sloping area to the north of the lagoon where the seaplanes entered and exited the lagoon. The 1998 report of radiation surveys indicates that the ramp and adjacent parking apron may have been contaminated by people working in Building 400 who could have spilled radium waste as it was carried across the taxiway to the lagoon. Figure 8-3.20.2 provides a site plan.
